Building Data / Receipt Information

Inspection Date: 8-22-16
 Client Name: Home Buyer
 Inspection Address: 1 Main St
 Inspected by: Michael Walsh KY License #102493

Approximate Age: 46 Years
 Style: One story
 General Appearance: Satisfactory
 Main Entrance Faces: For sake of the report the house faces South
 Weather Condition: Clear
 Temperature: 75°F +/-
 Ground cover: Damp
 Home Status: Vacant
 Buyer present: Yes

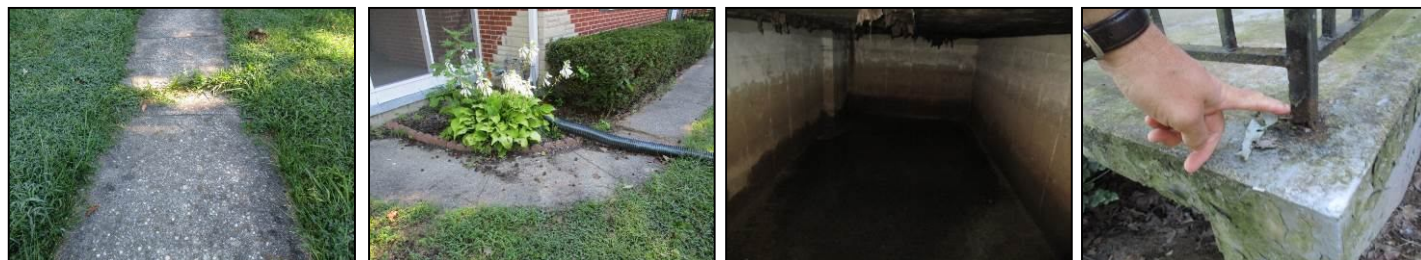
Negative grade at:	<input type="checkbox"/> East <input type="checkbox"/> West <input checked="" type="checkbox"/> Trim back trees/shrubberies	<input type="checkbox"/> North <input type="checkbox"/> South	<input checked="" type="checkbox"/> Flat grade <input type="checkbox"/> Recommend window wells/covers <input type="checkbox"/> Wood in contact with soil	
Retaining Wall:	Visual Condition: <input type="checkbox"/> Satisfactory <input type="checkbox"/> Marginal <input type="checkbox"/> Poor	<input type="checkbox"/> Yes <input checked="" type="checkbox"/> No		
General Comments	<p>Maintain a positive drainage slope away from the foundation. Trim vegetation away from the house. Settlement in concrete walkways has created tripping hazards and slope back toward the foundation. Not in use cistern is accessible through wood panel covering window in rear wall of side screened porch. Metal railing post at rear raised walkout slab is rusted through; repair for safety.</p>

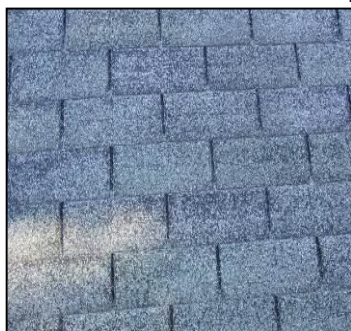
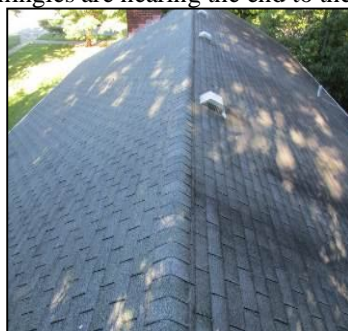
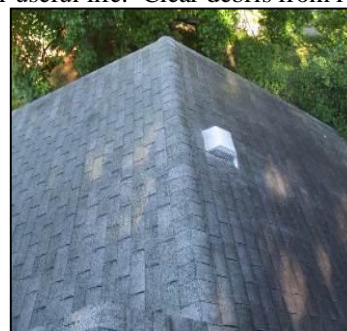
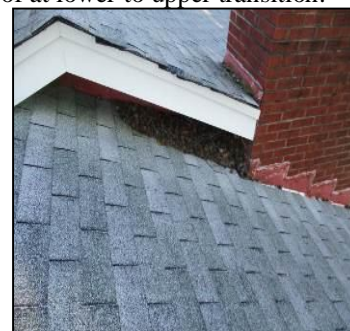
The roof covering is in overall marginal to poor condition showing excessive signs of aging; shingles are nearing the end to their useful life. Clear debris from roof at lower to upper transition.

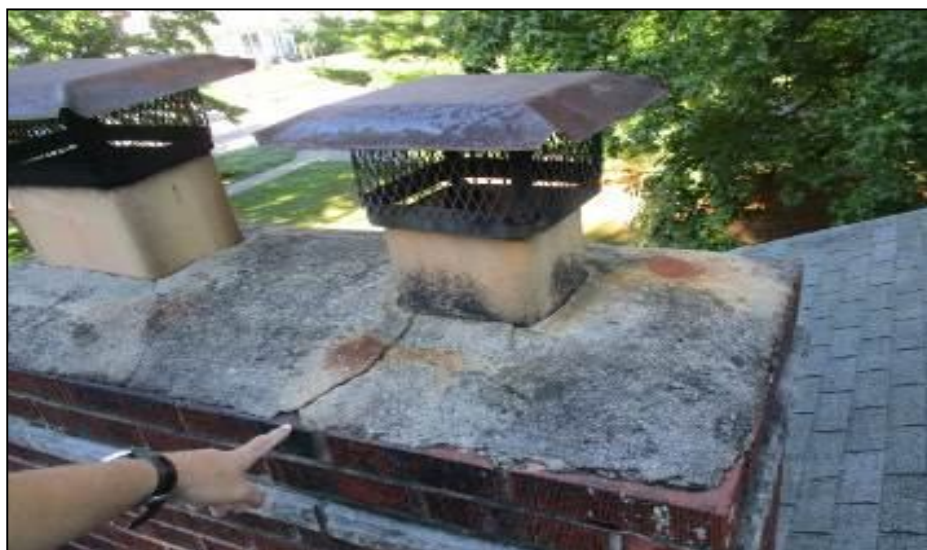
Window screens not installed. Cracking noted in masonry chimney cap repair to seal out moisture.

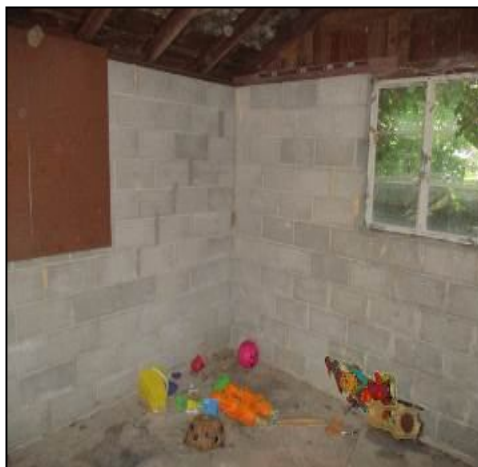
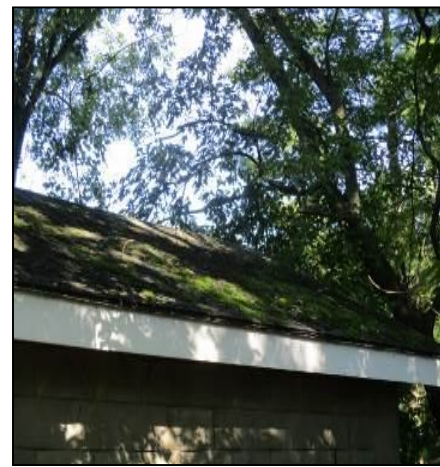
Terminate wire in garage near light fixture properly. Step cracking noted in garage walls and floor has heaved upward and cracked; repair as needed. Garage roof is in overall poor condition and partially covered in moss. Consider installing gutters and downspouts at garage to ensure proper drainage away from the structure.

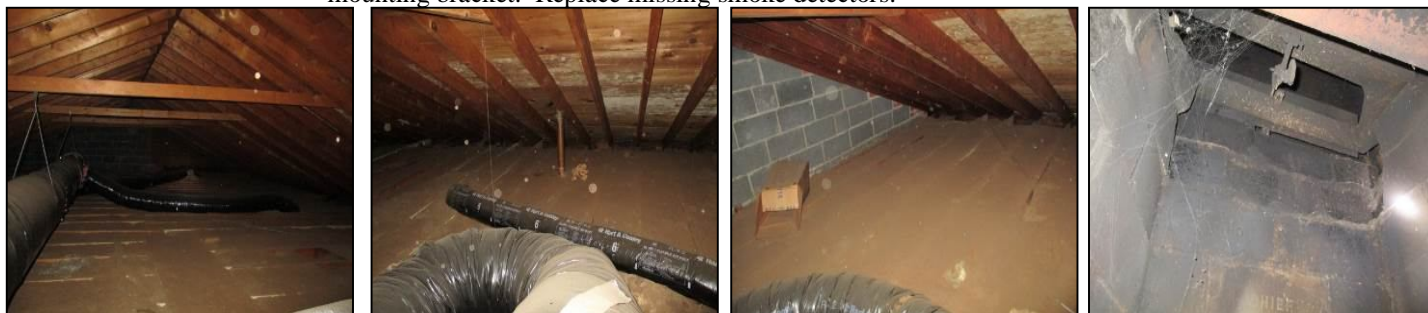
Rafters appeared to be in overall adequate condition. Roof sheathing, examined from the attic, showed no major defects or moisture damage. Insulation was poor and should be improved. Ventilation was normal. Repairs recommended in fireplace prior to operating; several brick have shifted leaving small to large open voids, flue is soot covered and damper plate is dislodged from mounting bracket. Replace missing smoke detectors.

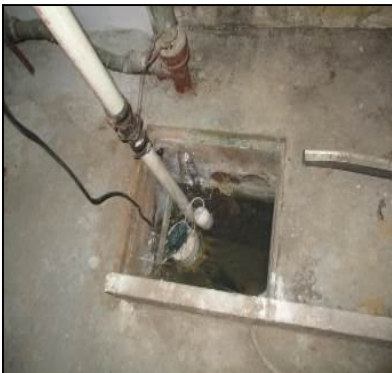
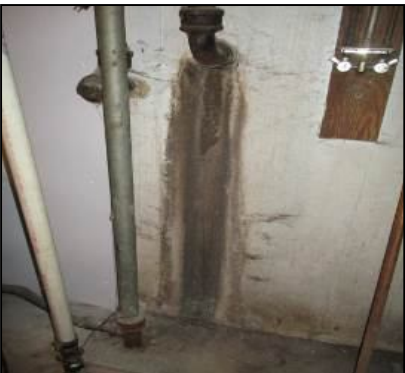
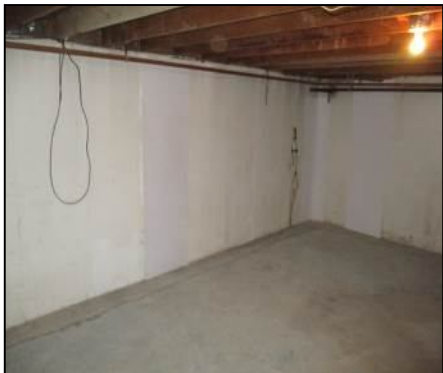
Drain Tile (See Remarks page)			Palmer valves (See Remarks page)		
Girders (1), Columns (2)					
Condition:	<input checked="" type="checkbox"/> Steel 1, 2	<input type="checkbox"/> Wood	<input type="checkbox"/> Block	<input type="checkbox"/> Concrete	<input checked="" type="checkbox"/> Not visible
	<input checked="" type="checkbox"/> Satisfactory 1, 2	<input type="checkbox"/> Marginal	<input type="checkbox"/> Poor	<input type="checkbox"/> Stained/Rusted	
Joists					
	<input checked="" type="checkbox"/> Not visible	<input checked="" type="checkbox"/> Wood	<input type="checkbox"/> Steel	<input type="checkbox"/> Other	
	<input type="checkbox"/> 2x8	<input checked="" type="checkbox"/> 2x10	<input type="checkbox"/> 2x12	16 inches on center	
General Comments					
<p>East portion of the basement is finished living space; floor, wall and ceiling areas are covered and not visible. Visible portion of foundation walls, floor and framing appear satisfactory. Water capture system installed at perimeter of basement; follow up with seller for possible warranty information. Drain line from water capture system is piped into the gray water crock; by current standards ground water drainage systems should not be piped into sanitary drains. Consider installing back up system for sump drainage pump in basement. Small copper lines through front wall of house indicate past/potential presence of heating oil tank; follow up with seller for additional information. Older moisture staining noted on rear wall in unfinished portion of basement below terminated plumbing drain lines; monitor area for potential seepage in the future and seal as needed.</p>

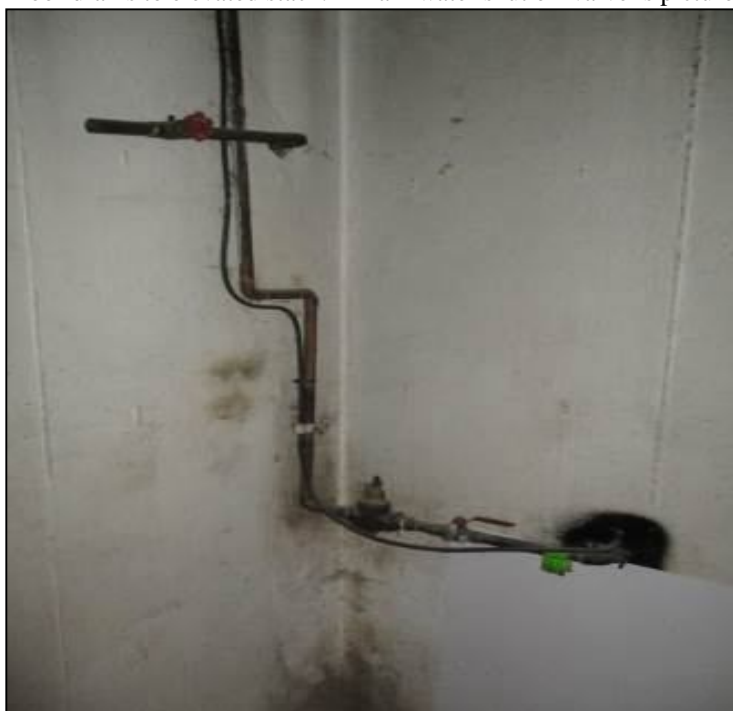
Water Heater #1	Brand name: General Electric		Serial #: Q111324300	
	<input type="checkbox"/> Gas	<input checked="" type="checkbox"/> Electric	<input type="checkbox"/> Oil	<input type="checkbox"/> Other
	Capacity: 40 gallons		Approx. age: 3 yr.(s)	
Relief valve:	<input checked="" type="checkbox"/> Yes <input type="checkbox"/> No	Extension proper:		<input checked="" type="checkbox"/> Yes <input type="checkbox"/> No <input type="checkbox"/> Missing
Vent pipe:	<input checked="" type="checkbox"/> N/A	<input type="checkbox"/> Satisfactory	<input type="checkbox"/> Pitch proper	<input type="checkbox"/> Rusted <input type="checkbox"/> Other
Water Softener	(Unit not evaluated)			
	<input type="checkbox"/> Yes <input checked="" type="checkbox"/> No	Plumbing hooked up: <input type="checkbox"/> Yes <input type="checkbox"/> No		
General Comments	Pump in basement is acting as a gray water lift pump to raise waste water from laundry and floor drains to elevated stack. Main water shut off valve is pictured below.

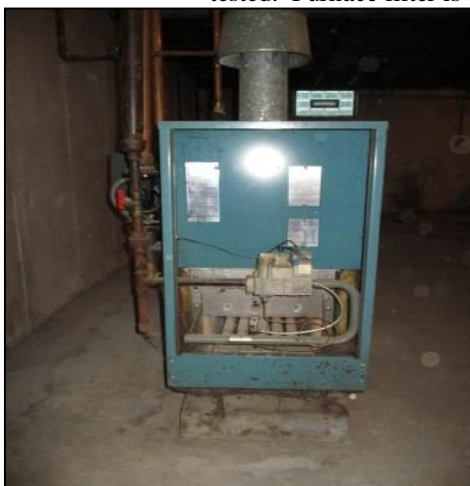
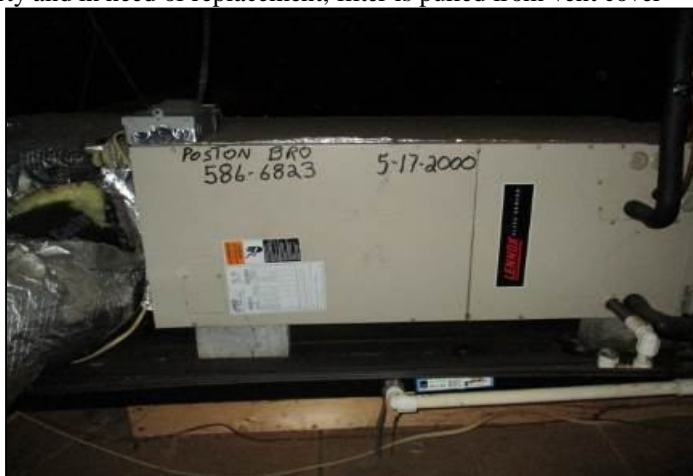
Operated:	When turned on by thermostat: <input type="checkbox"/> Fired <input type="checkbox"/> Did not fire		
Operation:	Satisfactory: <input type="checkbox"/> Yes <input type="checkbox"/> No <input type="checkbox"/> Recommend HVAC technician examine		
Others	<input checked="" type="checkbox"/> N/A		
	<input type="checkbox"/> Electric baseboard <input type="checkbox"/> Radiant ceiling cable <input type="checkbox"/> Gas space heater		
	<input type="checkbox"/> Woodburning stove (See Remarks page)		
General Comments	Boiler was not operated due to outside temperature; unit is beyond the normal design life for this type. Air handler in attic for cooling system is older though operated properly when tested. Furnace filter is dirty and in need of replacement; filter is pulled from vent cover

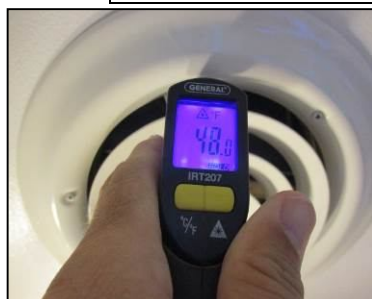
The A/C unit operated properly when tested though is beyond the typical design life for this type of equipment; budget for future replacement.

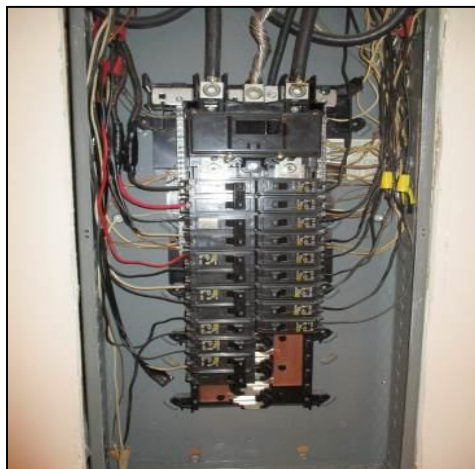
Random testing of electrical outlets revealed several are three prong though are not grounded; repair as needed. Panel size is compatible with service size.
